CRYSTAL LAKE DAM

NDI ID NO. PA-00096
DER ID NO. 646

PHASE I INSPECTION REPORT
NATIONAL DAM INSPECTION PROGRAM

JANUARY 1981

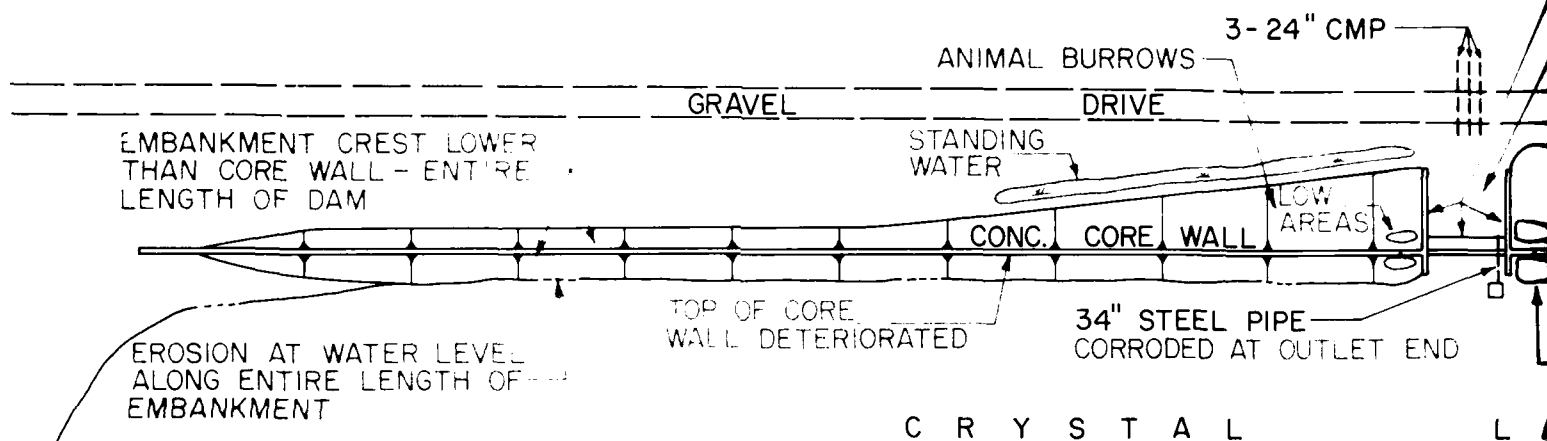
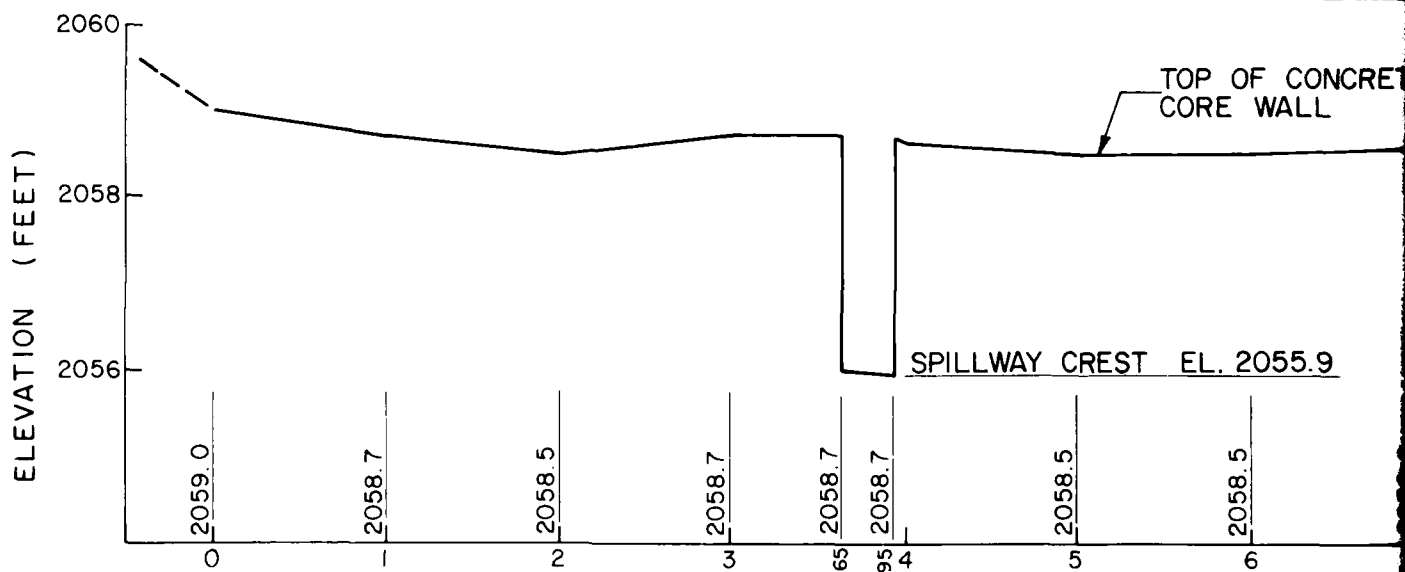
PROFILE-TOP OF DAM

The settlement along the crest of the dam is probably the result of poor compaction during construction, rather than a structural failure, since it was observed during inspections as early as eight months following completion of the dam. It was also reported during a construction inspection by the Commonwealth that the embankment soil was too wet to permit adequate compaction. The inspection report also stated that a significant amount of settlement would occur if the compaction techniques were not improved. The low areas on both sides of the spillway may also be caused by improper compaction, possibly during reconstruction of the spillway in 1968. The erosion at the normal pool level on the upstream slope is not a serious problem at this time, but could develop into a hazard if it is allowed to continue unchecked. The wet area at the toe of the dam, burrowing animal holes, and deteriorated corewall are not, at this time, considered detrimental to the structural stability of the dam.

VISUAL EXAMINATION OF	OBSERVATIONS	REMARKS OR RECOMMENDATIONS
JUNCTION OF EMBANKMENT WITH: Abutment Spillway Other Features	20-ft. section of embankment is 3 feet low on right side of spillway; embankment at left end of spillway is 2 feet low.	No problems observed at abutments; low areas should be restored to original grade.
ANY NOTICEABLE SEEPAGE	standing water at toe from left edge of spillway to 150 feet left of spillway; wet areas at toe to right of spillway.	Water is reportedly observed year-round.
STAFF GAGE AND RECORDER	None	
DRAINS	None observed.	
COREWALL	Earth embankment is lower than concrete corewall; some places as much as three feet	Embankment should be restored to original grade. Top of corewall is deteriorated in some places.
